NRCS Actions: NRCS staff have been in the field since Sunday morning, evaluating damage across the entire area affected by the June 7 - 8 storms and the subsequent June 12 storms. NRCS is working closely with local partners, County staff, and the State Dam Safety Engineers, and taking precautions to ensure inspections are completed safely.

High Risk Projects: The Wisconsin State Conservationist has received approval for EWP exigency funds to provide emergency repairs for the following projects to reduce further damage to property -

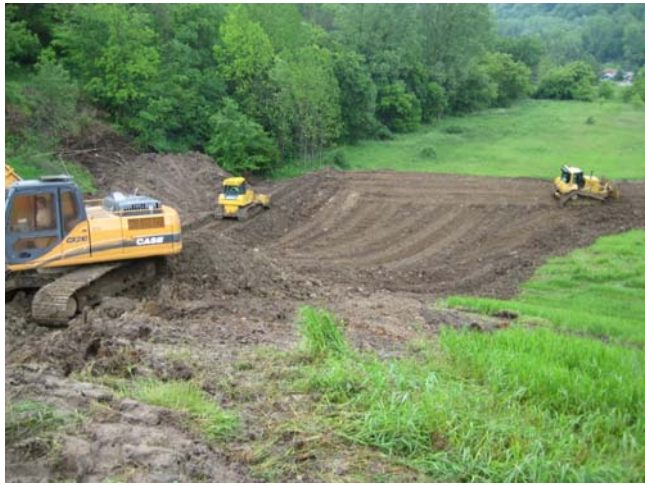
Primmer breach – 11 am June 12

West Fork Kickapoo 17 (Primmer) - The water level on June 9 was 2 feet over the top riser. Seepage and slumping from the right abutment has moved upstream to the base of the dam. A state highway, 2 homes, and a bridge are at risk downstream from the dam. An emergency controlled partial breach of the dam was started June 12, and is 90% complete. The breach will reduce the potential damage from future storm events.

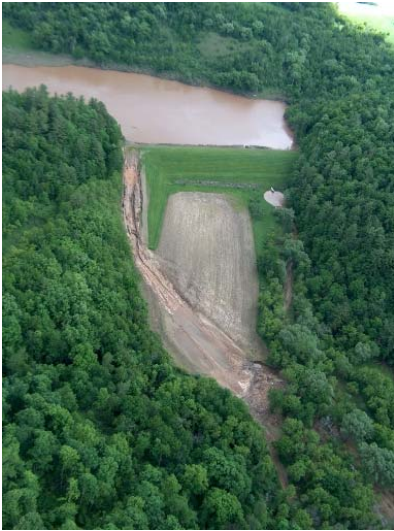
Hidden Valley – June 11

West Fork Kickapoo 4 (Hidden Valley) is in danger of further significant damage with a future rain event. The auxiliary spillway sustained significant erosion. Engineers are working on the exigency construction plans now.

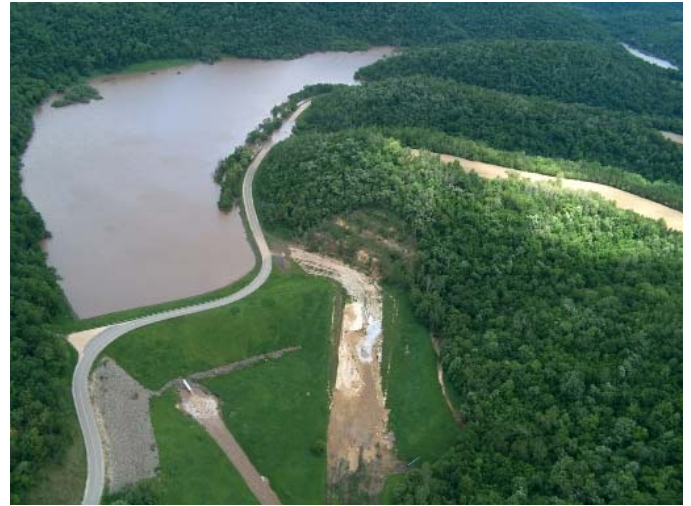
Runge Hollow – June 11

Bad Axe 12 (Runge Hollow) - Flow was up to, but not over the control section of the auxiliary spillway. Water is coming through the left abutment and into the previously completed temporary chute fix. June 12 check showed good correlation of flow with pool level. Engineers are working on the exigency construction plans now.

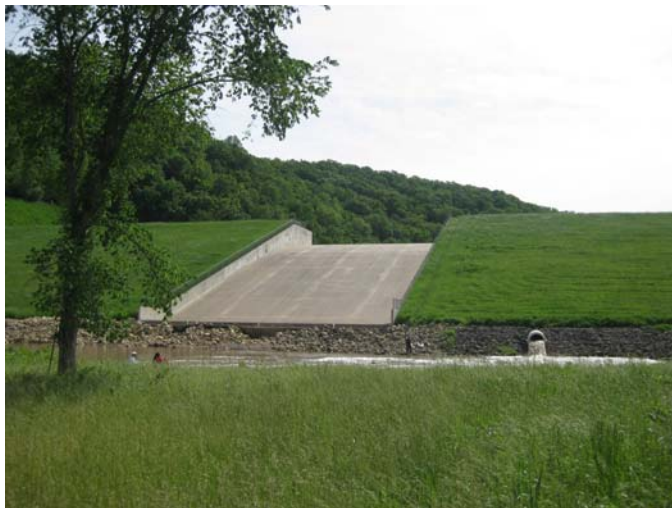
Duck Egg – June 13

Bad Axe 11 (Duck Egg) is in danger of further significant damage with a future rain event. Flow on June 9 was 4 feet over the auxiliary spillway crest, causing significant damage to the outlet. Engineers are working on the exigency construction plans now.
